The Hard Carbon Coating

Subject: Carbon Raptor® PACVD vs. PVD film properties

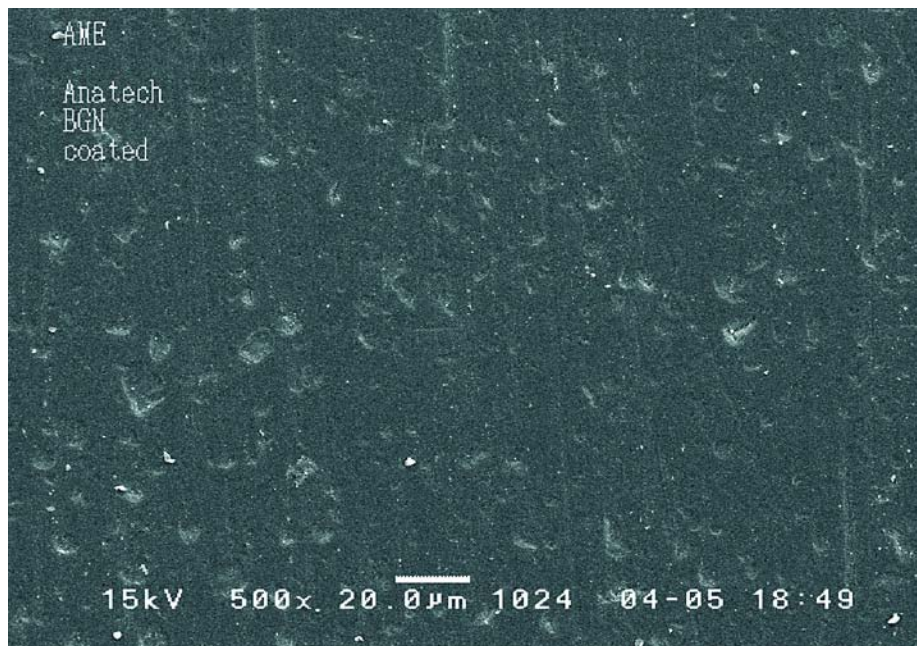
Figure 1. Carbon Raptor on the Nationwide™ sample at 500x. Carbon Raptor is very smooth over much of the area and shows pits and some scratches due to use of the part in an engine over 1100 miles. This is typical of a PACVD film. Carbon Raptor's even wear is attributed to its lack of grain structure, since there are no grains to pull out of the film during use. The film is characterized by tightly chemically and energetically bonded orthogonal Carbon.

The Carbon Raptor coating on the Nationwide sample is relatively smooth at lower magnification, except where worn, as shown in Figure 1. Some light scratching in the direction of the cylinder length is also visible. Both the pits and the scratches are due to the use of this part in an engine for 1100 miles.

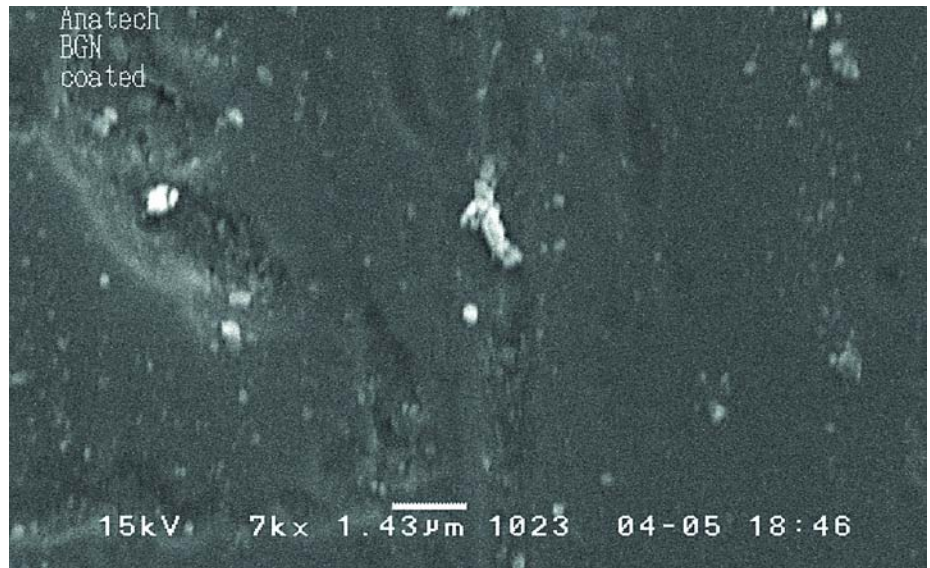
Higher magnification reveals the size and irregular shape of the pits, and further that the pits seem to contain some additional debris, as seen in Figure 2. However, no grain structure such as that seen in the PVD DLC sample was present in the

Figure 2. Carbon Raptor on the Nationwide sample at 7000x. Pits are irregular in shape, and there is debris present in and around the pits. Carbon Raptor is very smooth over much of the area and shows pits and some scratches due to use of the part in an engine over 1100 miles. The surface is otherwise smooth as contrasted with the PVD DLC.

Nationwide sample, as between pits and scratches the surface remained smooth in appearance, even at 7000x magnification. The grain size is exceedingly small, so there is little long-range order in the Carbon Raptor DLC.

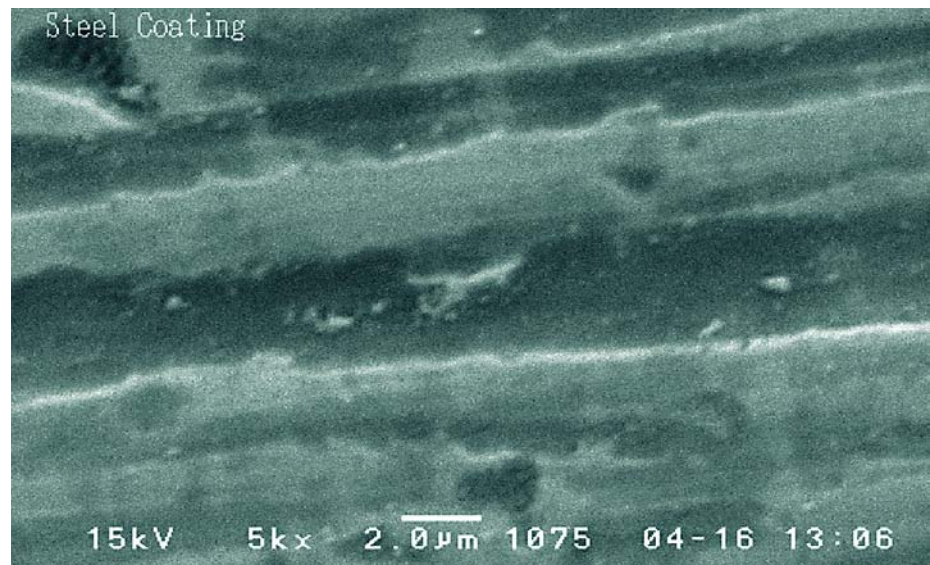
Figure 3. Carbon Raptor on a new, unused steel sample at 5000x. Edges of the scratches are rounded, showing that they exist in the substrate surface, and that Carbon Raptor covers them conformally. Conformal coverage is typical of a PACVD deposited film. No grain structure such as that seen in the PVD DLC is present here. This is an attribute of Carbon Raptor's microcrystalline graphite with C-H bonding, that is, tightly chemically and energetically bonded, laterally overlaid, orthogonal Carbon.

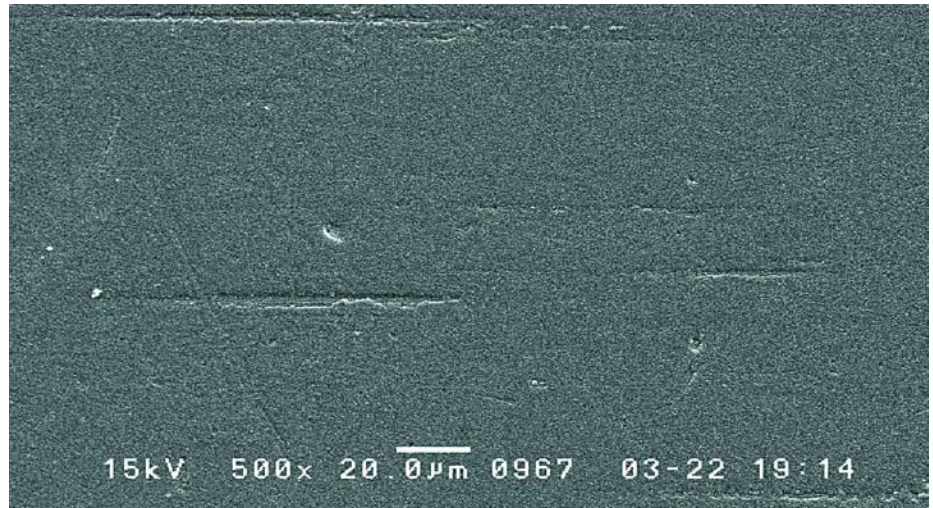
Examples of the PVD DLC surface are shown below. The coating appears to be relatively smooth at lower magnification, as shown in Figure 4, however, some radial cracks and a few pits are visible. Higher magnification reveals a significant amount of structure as seen in Figure 5. Grain structure is visible at 7000x and consists of grains ranging in size from roughly

Figure 4. PVD DLC at 500x on a new, unused lifter, seems relatively smooth, with some radial cracks and a few pits. The origin of the cracks may be due to differential cooling of dissimilar layers that have different coefficients of expansion.

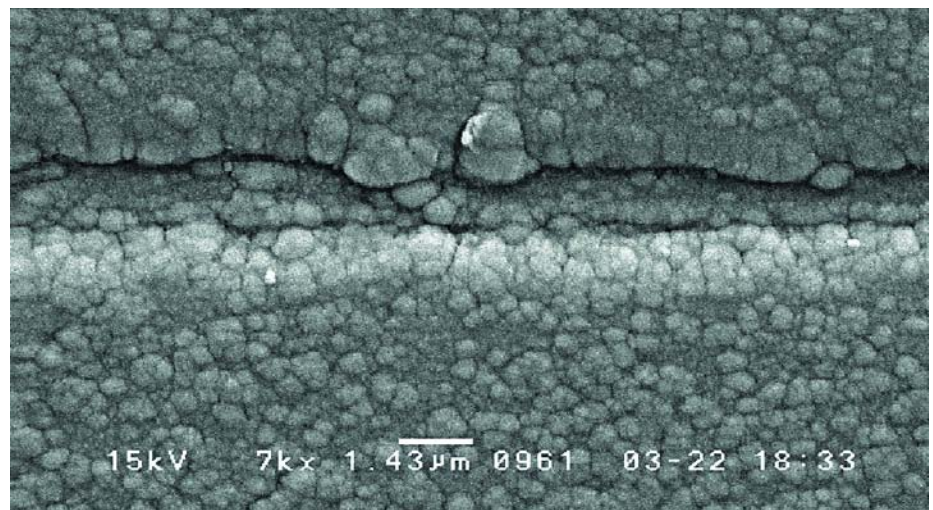
Figure 5. PVD DLC at 7000x. Crystalline grain structures ranging from 0.1-1.6 micrometers are present on the surface. The crack is caused by growth plate defects formed during coating, as grains are seen on the exposed walls of the crack. This can be a typical PVD shortcoming. When a 1.6 micrometer grain rips from a 2 to a 4 micrometer thick film during use, it will look as though the film was gouged at that point and down the path of applied force.

0.1 micrometer to 1.6 micrometer in diameter lateral to the surface and elongated by a measure of columnar growth, as judged by the grains at the crack edges. Cracks are related to growth plate defects formed during coating, a typical Physical Vapor Deposition (PVD) shortcoming. Support for the growth plate conclusion comes from

the fact that additional crystalline growth is apparent inside the cracks, possibly from previously formed layers, such as a seed layer. Some cracks may be due to differential cooling of dissimilar layers that have different coefficients of expansion. Support for the differential cooling conclusion is presented in the

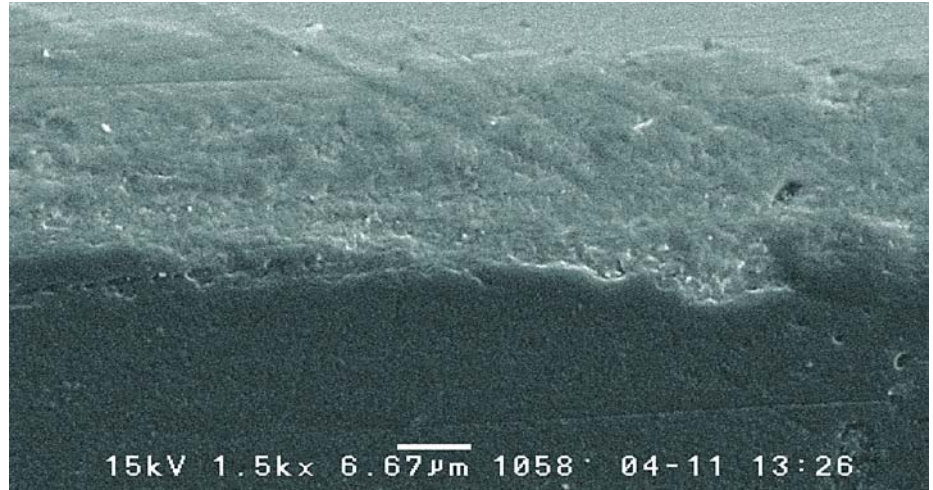
Tangential cross section views of the PVD DLC sample are shown in Figure 6 and Figure 7. A change in texture from the area close to the metal/DLC interface to the coating surface suggests a transition within the coating that probably plays a role in the bonding of the coating to the substrate. The substrate surface is still clearly delineated, however.

Figure 6. Tangential Cross Section (TCS) view of the PVD DLC coating. A change in texture occurs between the substrate /coating interface and the coating surface. The unpolished coating surface is at the bottom of the image. The center band is the polished coating, and the polished substrate is at the top. The thinner outer part of the coating in cross section has a different texture compared to the inner part.

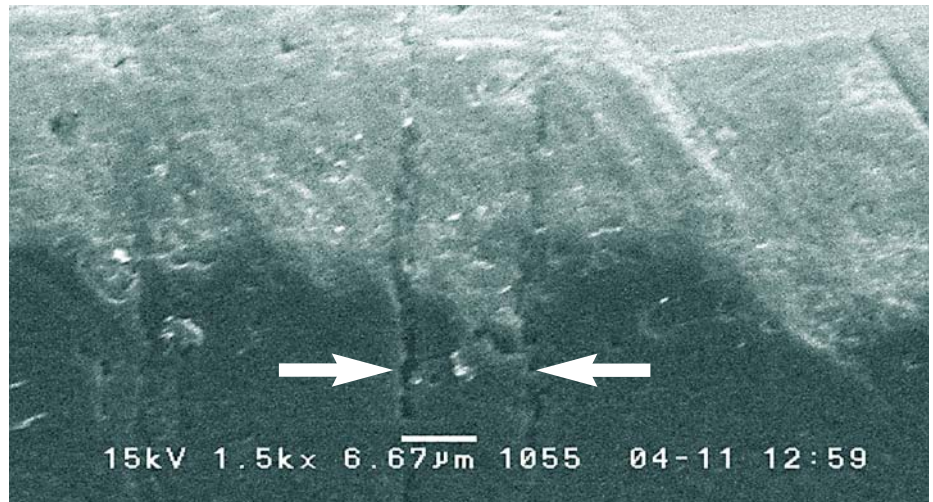
Radial cracks seen in the surface Scanning Electron Microscope (SEM) images, probably associated with differential cooling, can be seen in Figure 7 to extend through the full thickness of the coating to the metal surface.

Figure 7. Cracks seen in the surface of the PVD coating (at bottom) extend through the full thickness to the substrate interface (cracks are indicated by arrows). Radial cracks are associated with differential layer cooling, as they extend through the full thickness of the coating to the metal surface and have no grains deposited within them.
